SUBSURFACE EXPLORATION REPORT

ASHBURN PARK PEDESTRIAN BRIDGE

**Ashburn Park
Loudoun County PIN 117-40-6216
Ashburn, Virginia**

E.M. Tech Project No. 17-3196G

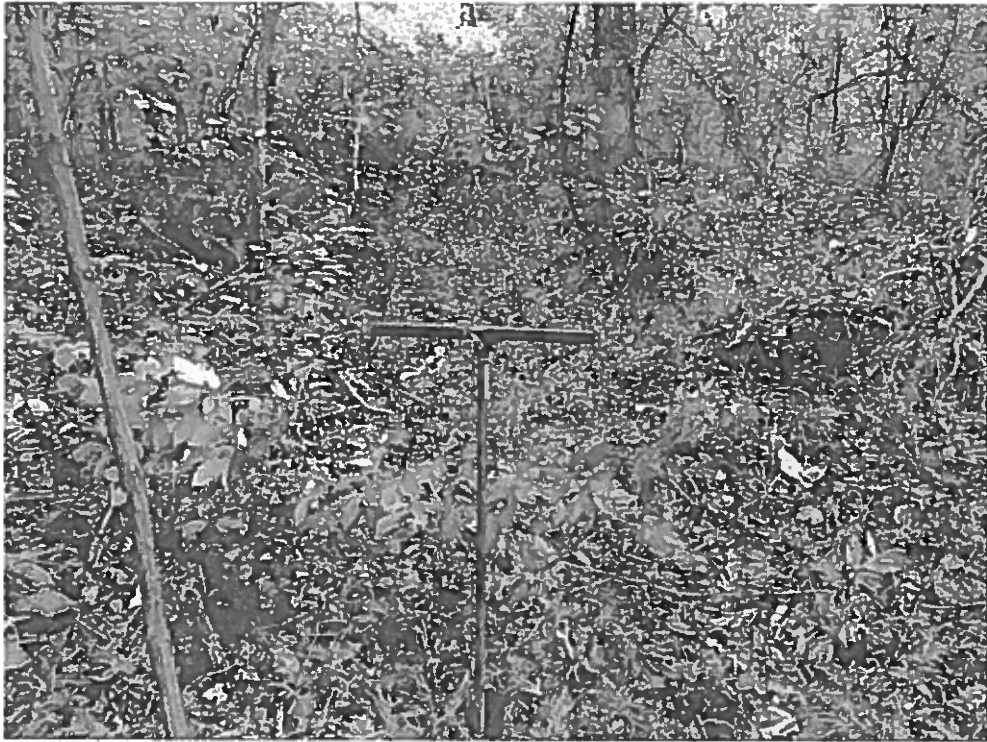
Photograph 7: View to the east showing Data Point 1 (Upland), taken east of the eastern unnamed tributary to Beaverdam Run, near wetland flag B-8.

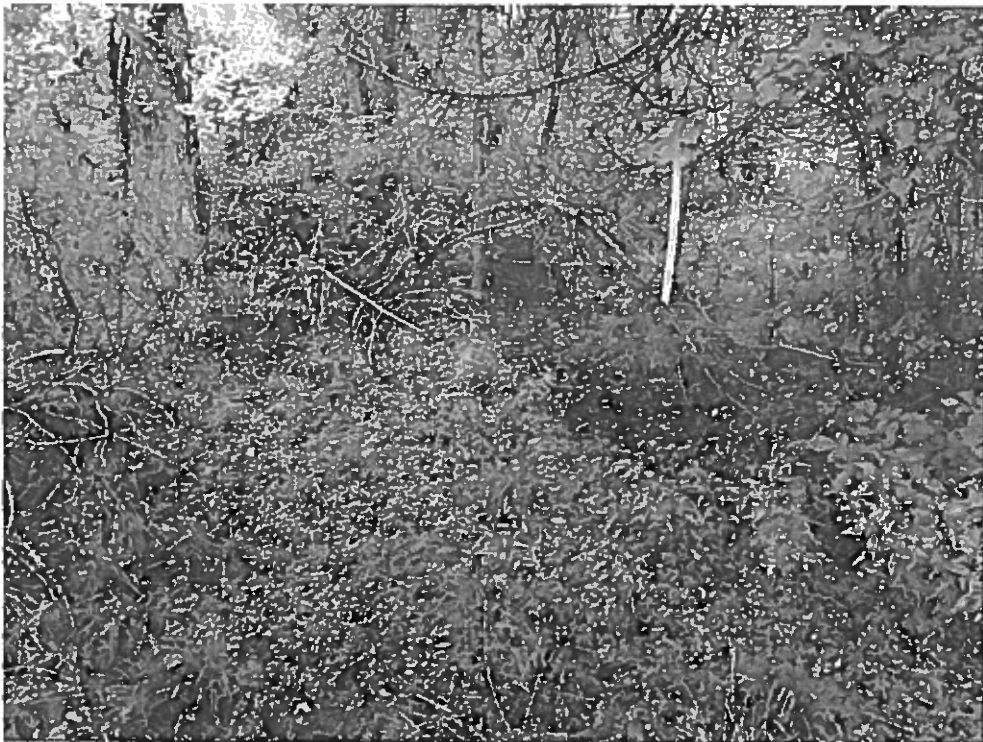
Photograph 8: View to the northwest showing Data Point 2 (PEM wetland), taken west of the western unnamed tributary to Beaverdam Run, near wetland flag E-2.

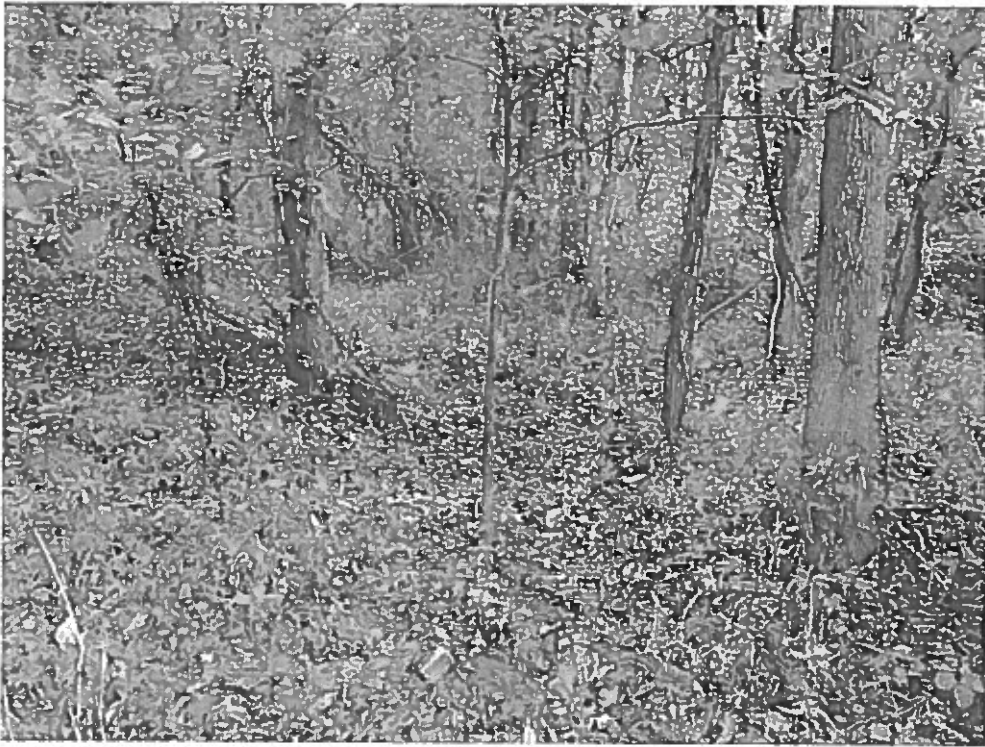
Photograph 9: View to the south showing Data Point 3 (Upland), taken south of Beaverdam Run.
